TO: Doug Halley, Director of Health, Acton
FROM: Jack Troidl, P.E. *JTB*
DATE: July 14, 2009
RE: I/I Investigation Results

ACTON, MA
SMOKE TESTING REPORT
JUNE 2009

Re: Acton, MA
Smoke Testing Report

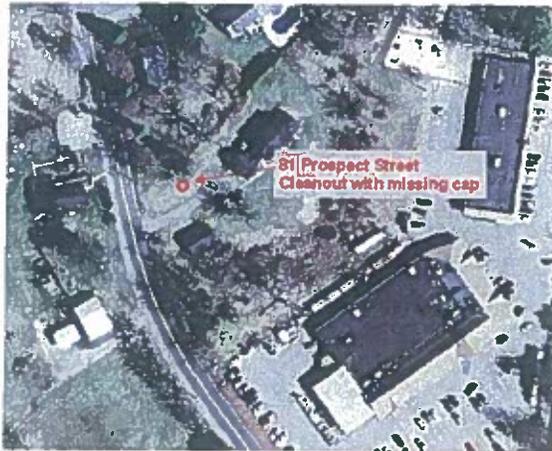
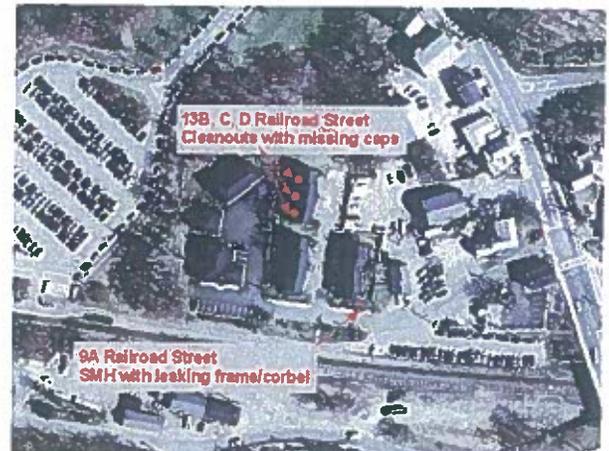
13B, 13C, 13D Railroad Street: On the west side of the apartment building, as shown in the diagram below, there are three 4-inch PVC pipes that are missing covers. It is evident that these PVC pipes are connected to the sewer system by means of SMH #103.

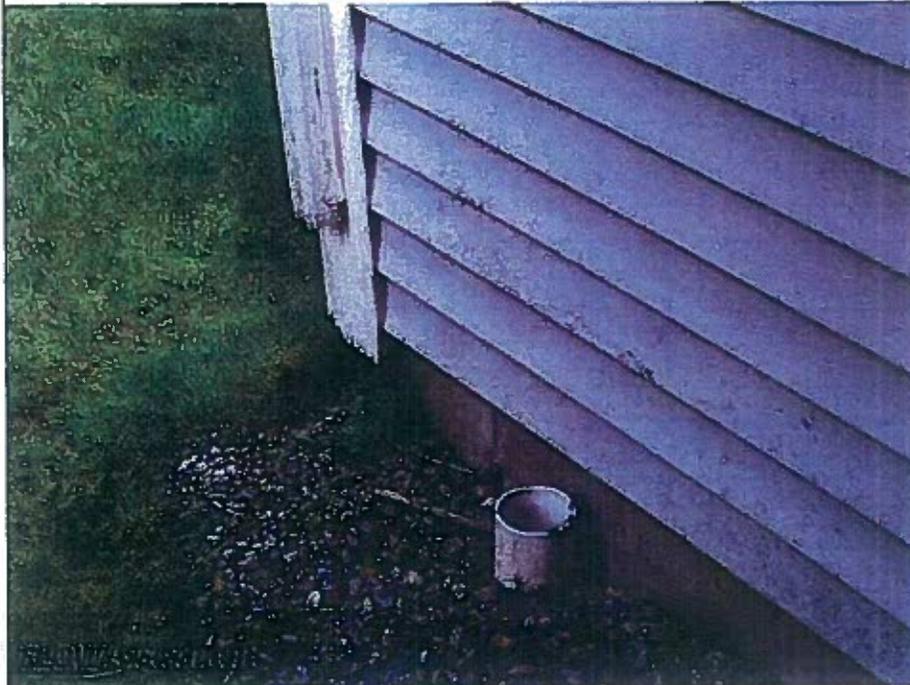
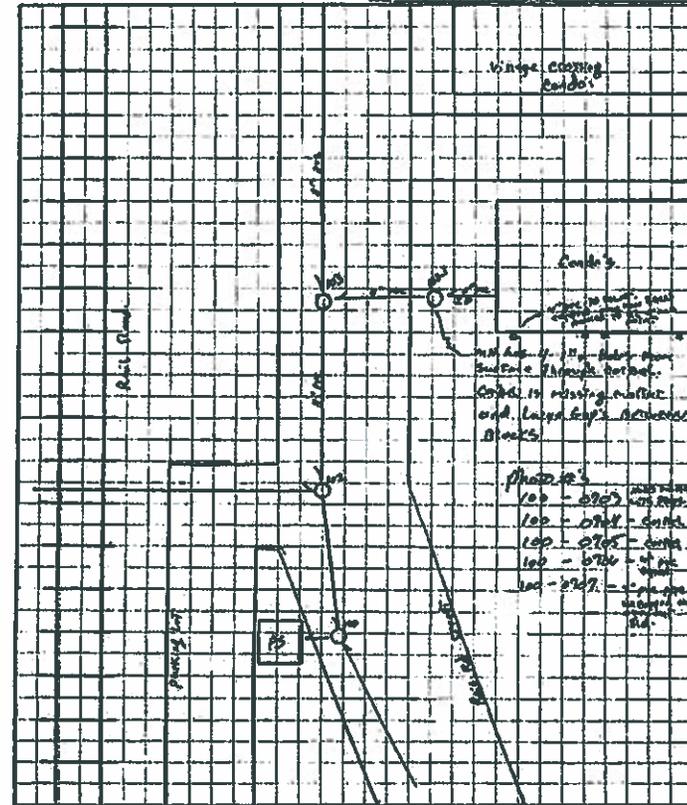
Three 4" PVC pipes with caps and one 4" PVC pipe without a cap, above grade located at 13B/13D Railroad Street. At one time they were directly connected to MH 103.1, but have since been repaired. - indirect connection

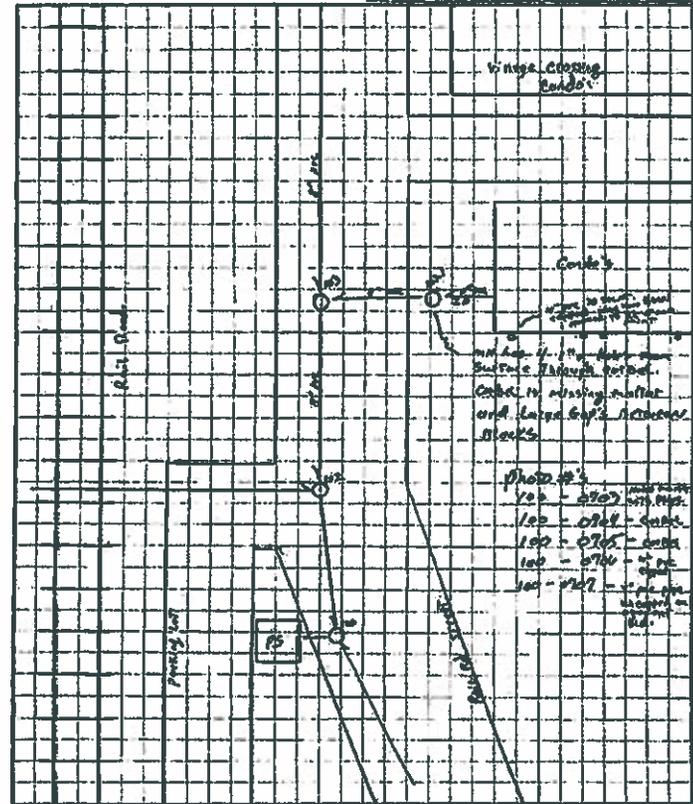
Image #: DSCF0705.jpg

MH 103.1 is missing mortar in the corbel - indirect connection

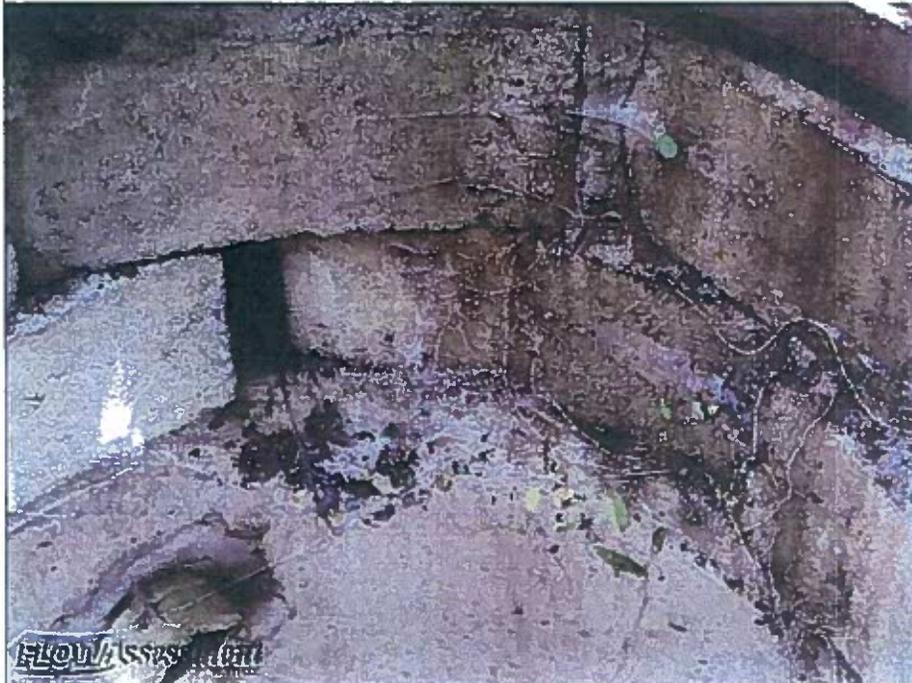
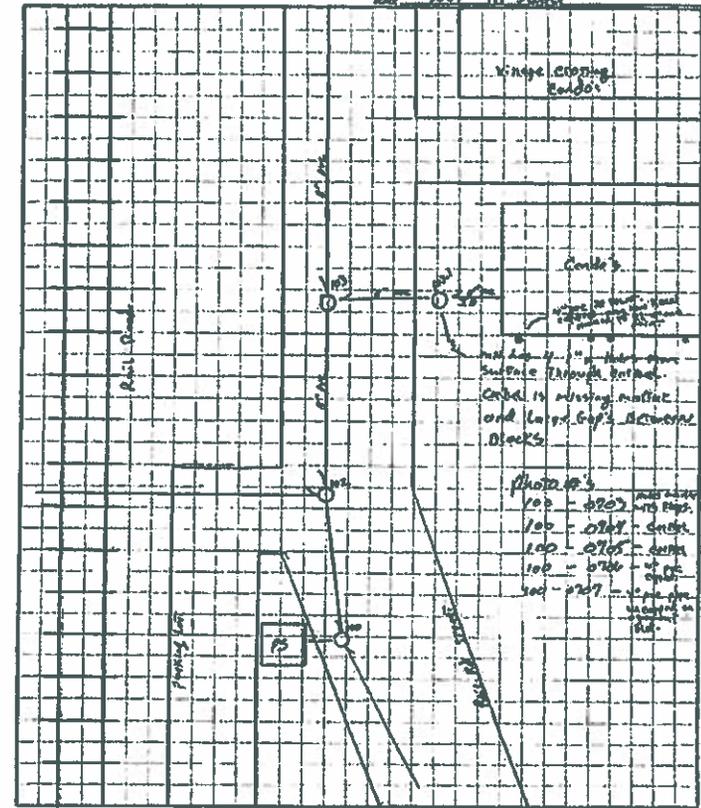
Image #: DSCF0704.jpg

MH 103.1 is missing mortar in the corbel - indirect connection

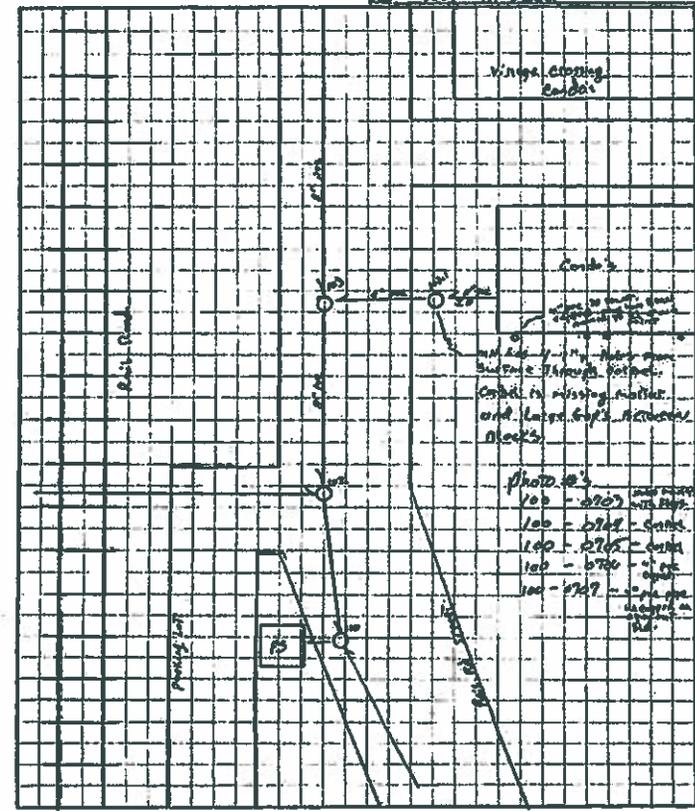
Image #: DSCF0703.jpg

MH 103.1 is not on map. MH 103.1 has four 1" holes in the corbel - indirect connection

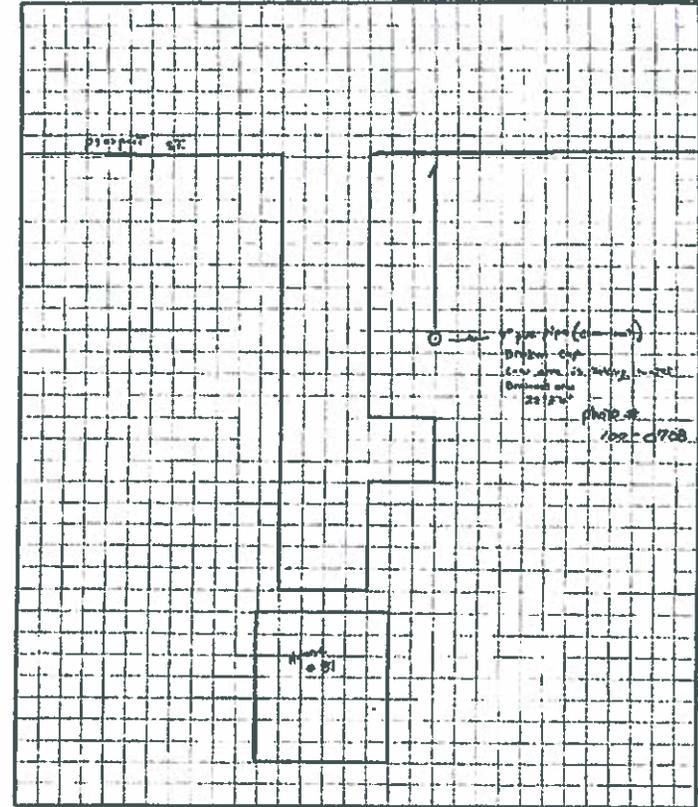
Image #: DSCF0708.jpg

Smoke from 4" PVC celanout cap that is broken and in a low area at 81 Prospect Street. Taking water during rain events - direct connection

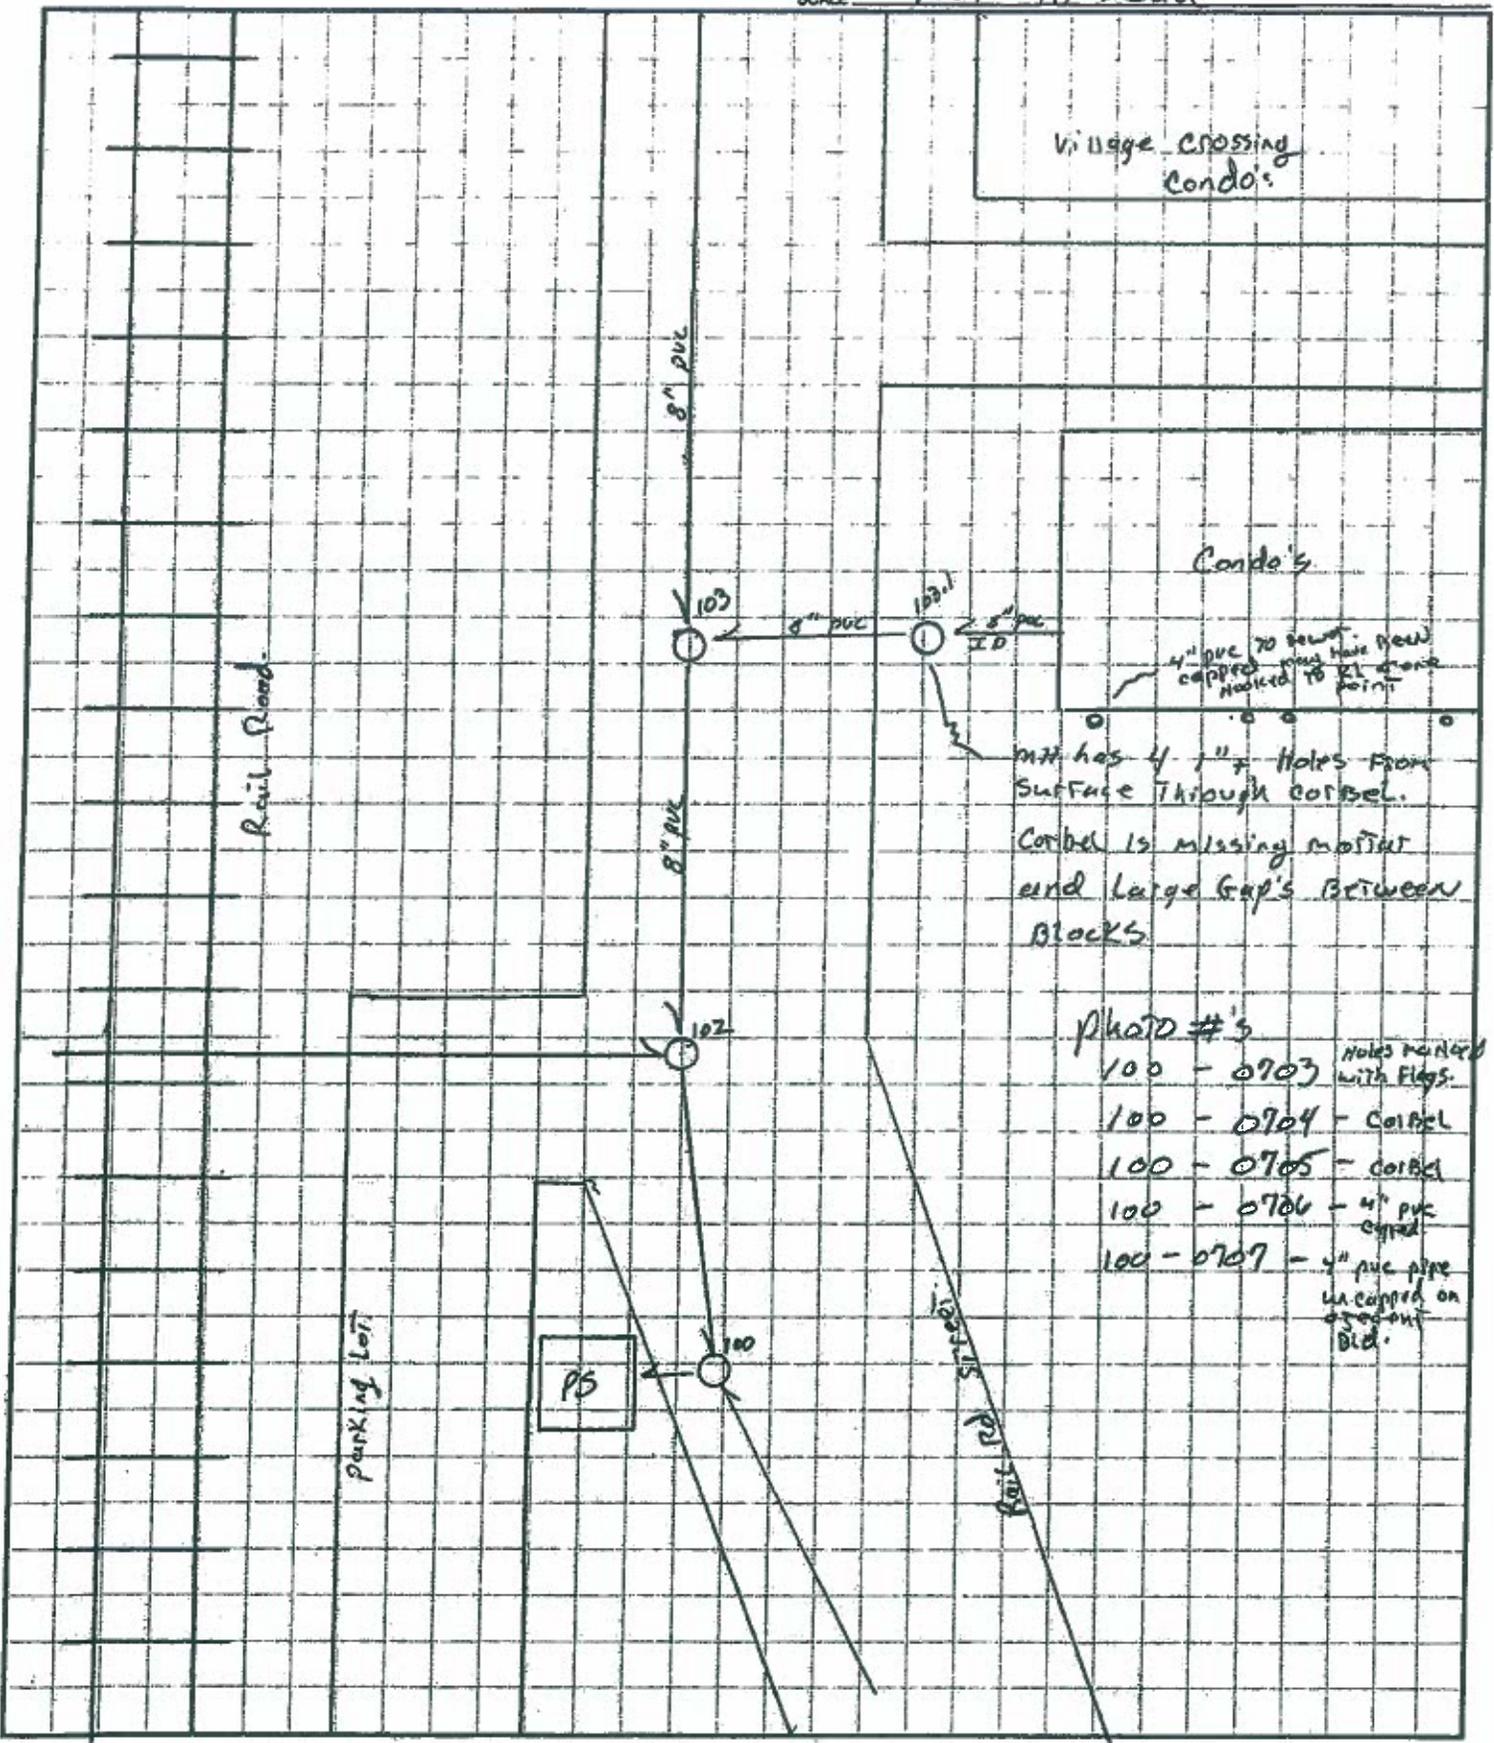
MH has 4 1" Holes From
 Surface Through Corbel.
 Corbel is missing mortar
 and large gaps between
 blocks

- Photo #'s
- 100 - 0703 Holes marked with flags.
 - 100 - 0704 - Corbel
 - 100 - 0705 - Corbel
 - 100 - 0706 - 4" PVC capped
 - 100 - 0707 - 4" PVC pipe uncapped on 0706-0707
