Tree Assessment and Windshield Survey Summary Report

Town of Acton, Massachusetts

April 2018

Prepared by:
Davey Resource Group, Inc.
1500 North Mantua Street
Kent, Ohio 44240
800-828-8312

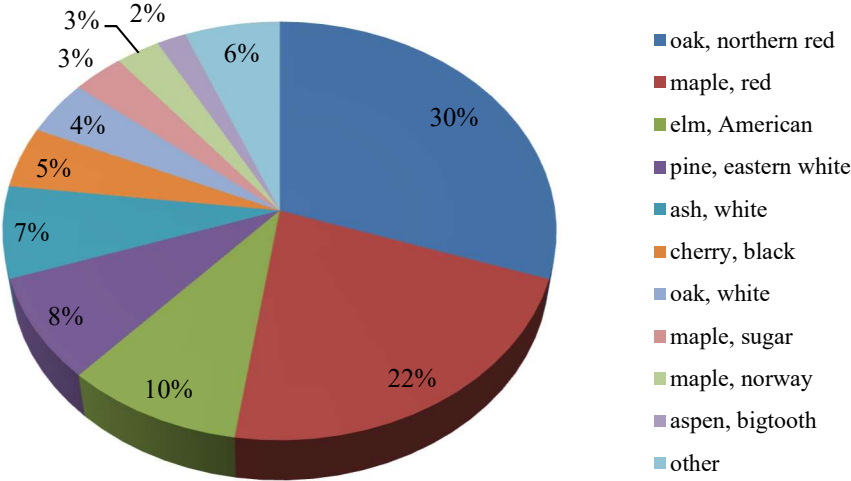
Figure 1. Hazard tree species composition found during windshield survey

Throughout the town of Acton, MA 108 miles of town roads sites were assessed, and 212 trees were identified as potential hazards during this survey. Figure 1 shows the species composition of these 212 trees.

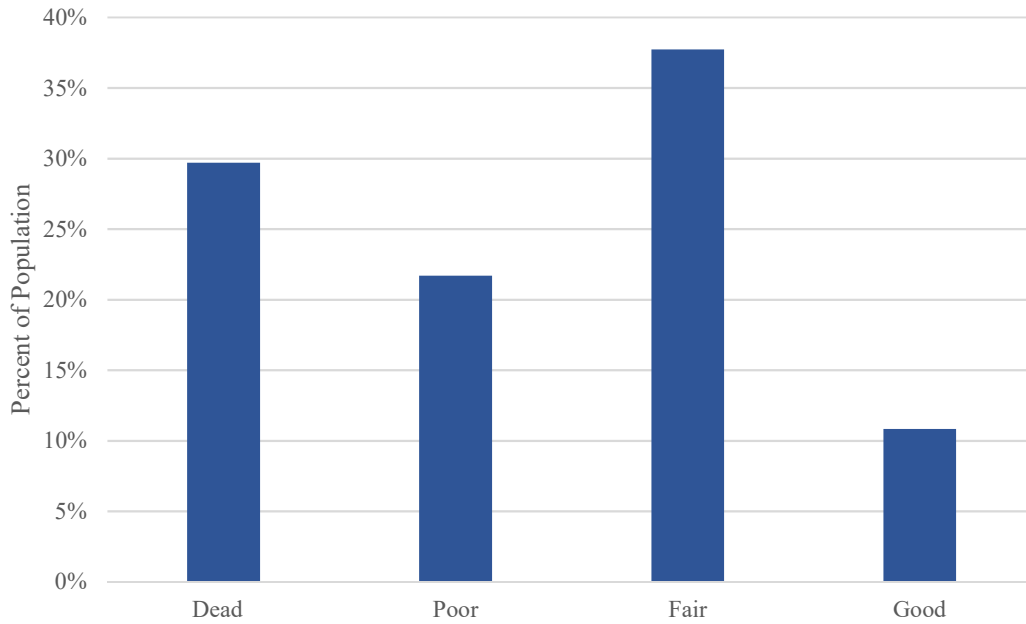
Figure 2. Overall condition of trees during windshield survey

Most of the inventoried ROW trees were recorded to be in Fair condition, 37%. Over 50% of the inventoried hazard trees were rated as poor or dead. Those trees that were rated as in good condition were included due to broken/dead hanging branches despite their otherwise good condition. Figure 2 illustrates the overall condition of the collected trees.

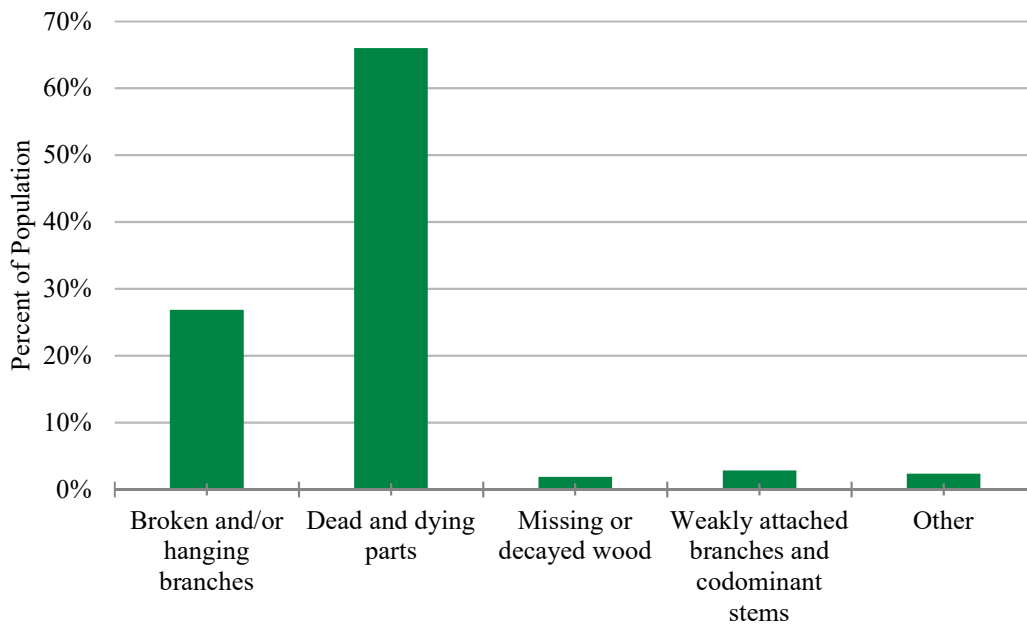
Figure 3. Defects found in trees during windshield survey

Primary maintenance refers to the task identified for a tree or site: removal, prune or N/A. Risk ratings were not collected for windshield survey trees as all trees collected were deemed to be hazard trees. Figure 3 illustrates the major defects found in these trees.

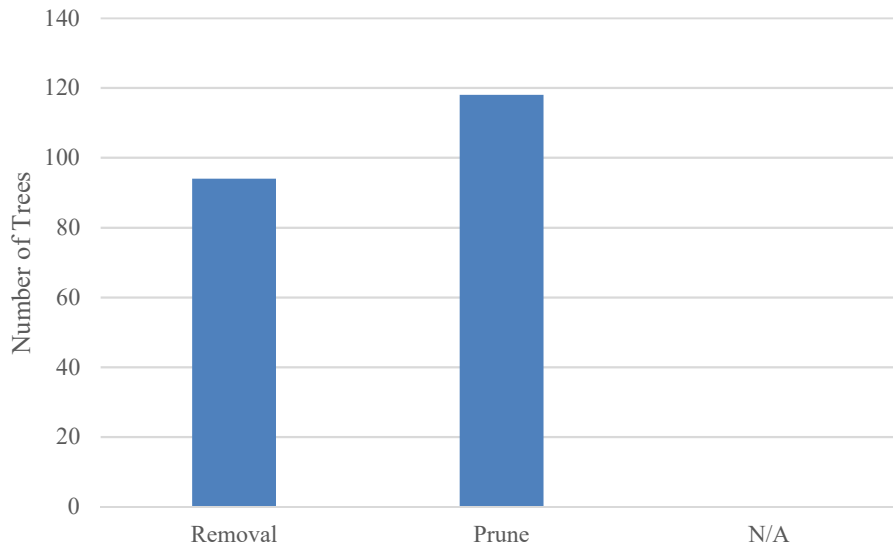
Figure 4. Maintenance needs for windshield survey

The inventoried population in Acton, MA has a total of 93 recommended removals and 115 recommended prunings. Figure 4 illustrates the maintenance recommendations for these hazardous trees.

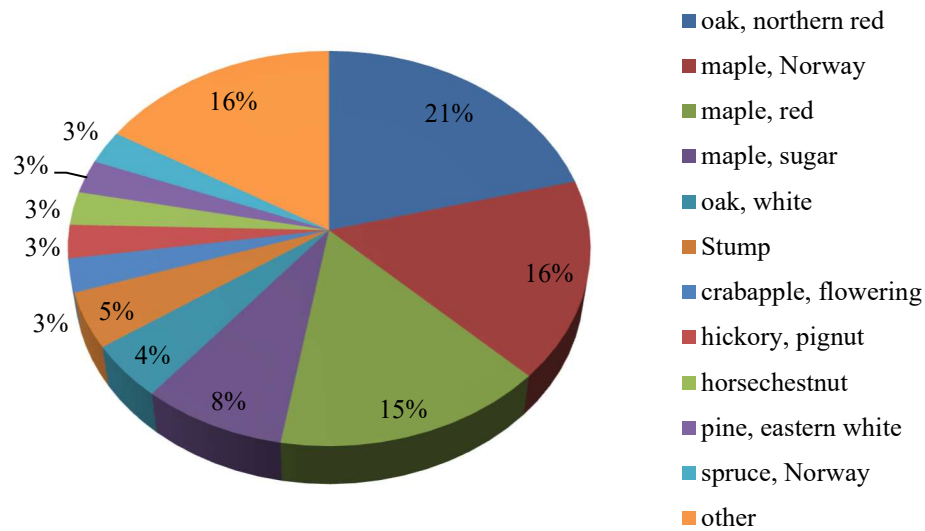
Figure 5. Species composition for Level 2 survey

Throughout the town of Acton, MA a level 2 survey was completed of 120 trees. Figure 5 shows the composition of the species of these trees.

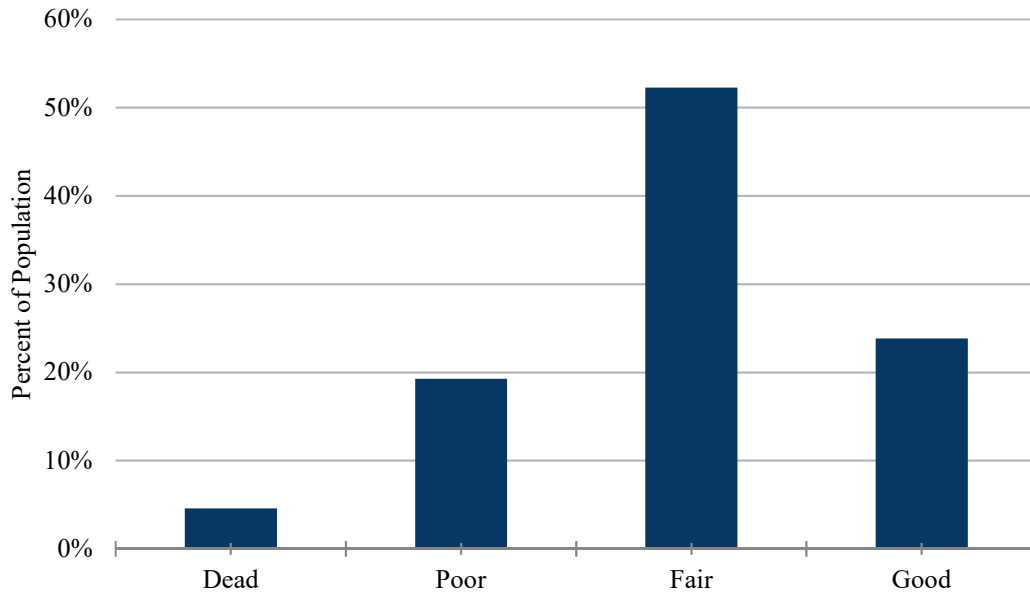
Figure 6. Tree condition found in Level 2 survey

Several factors were considered for the condition of each tree, including root characteristics; branch structure; trunk, canopy, and foliage condition; as well as the presence of pests. The condition of each inventoried tree was rated Good, Fair, Poor, and Dead. The majority of trees inventoried was rated as Fair or Good condition. Less than 30% of trees inventoried were rated as poor or dead condition.

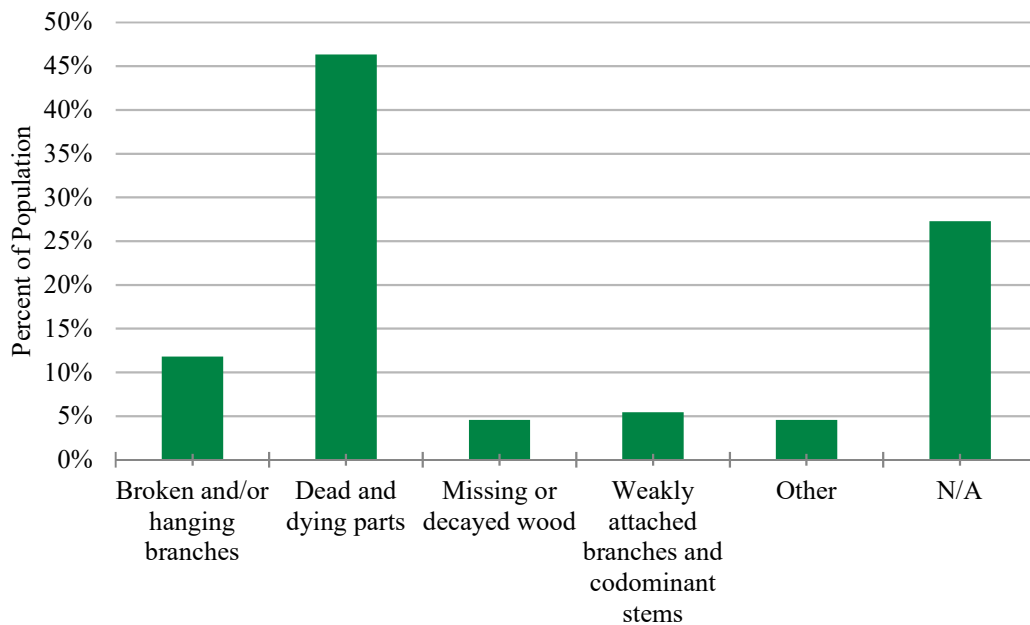
Figure 7. Defects found in trees during Level 2 survey

Primary maintenance refers to the task identified for a tree or site: removal, prune, or N/A. Risk is a graduated scale that measures potential tree-related hazardous conditions. A tree is considered hazardous when the potential risks associated with it exceed an acceptable level. Figure 7 illustrates the various defects that were found in the Level 2 assessment trees.

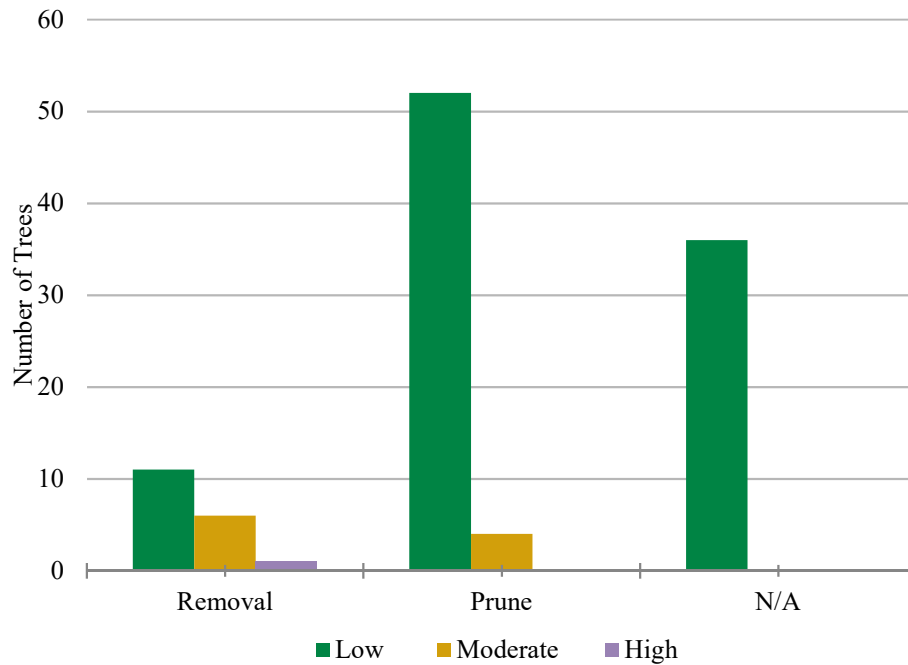
Figure 8. Risk values associated with maintenance needs in Level 2 survey.

DRG based the maintenance recommendations and risk values (Figure 8), in part, on the evaluation of species, diameter class, condition, impact of hazard, and defects found in the individual tree. Identifying and ranking the maintenance needs of a tree population enables tree work to be assigned priority based on observed risk. Once tree work is prioritized, it can be accomplished systematically to eliminate the greatest risk and liability first (Stamen 2011).

The inventoried population in Acton has a total of 14 recommended removals, 55 recommended prunings, and 34 with no action needed. Figure 8 expresses the risk values associated with each maintenance need.
