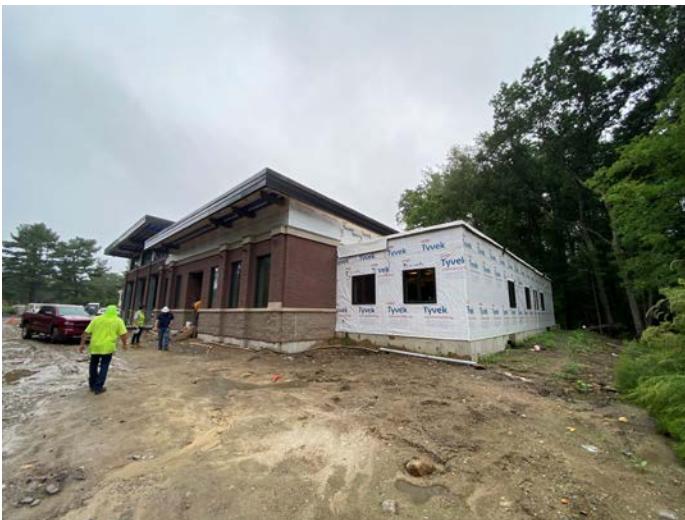
Overview of building from southeast

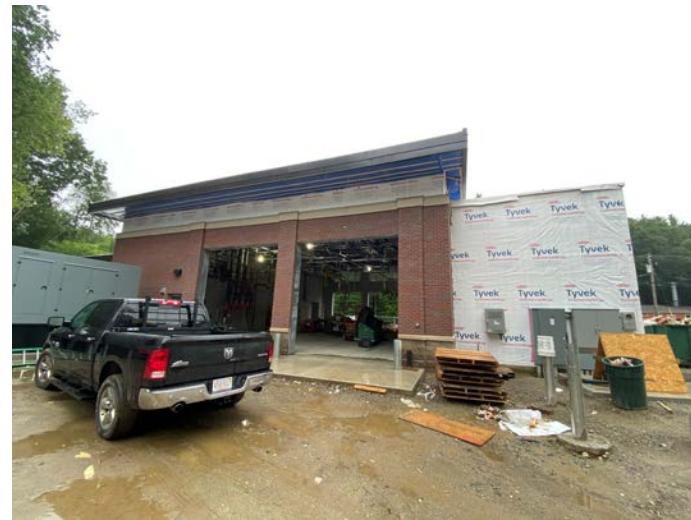
Overview of northwest side of building

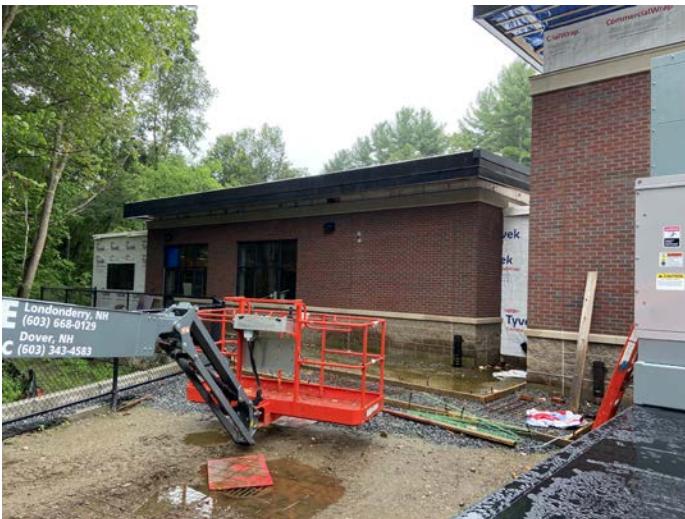
Overview of northeast side of building

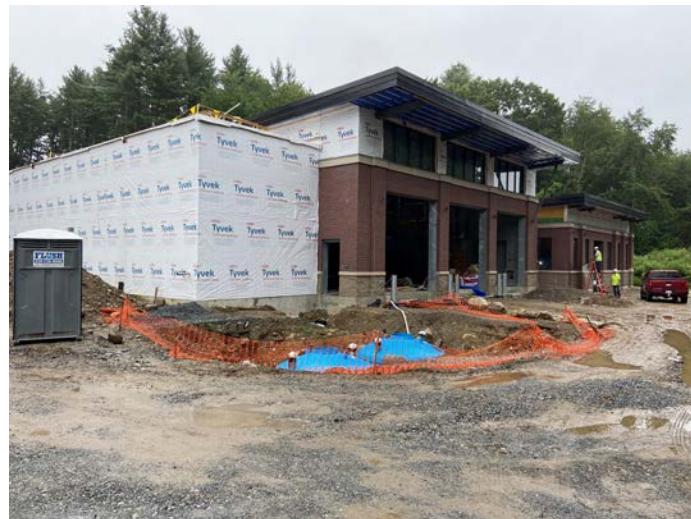
Overview of building from southwest

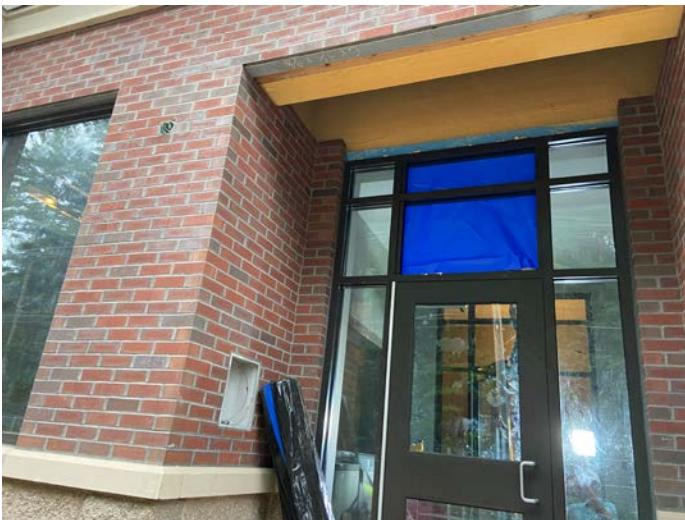
Temporary enclosure for interior climate control

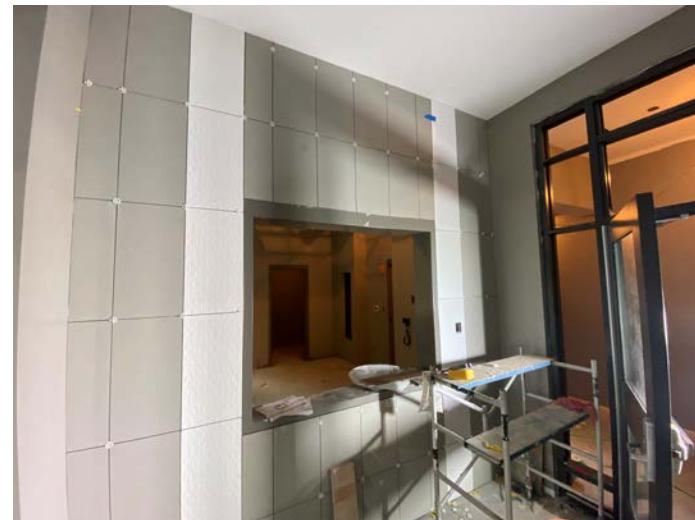
Vestibule tile wall

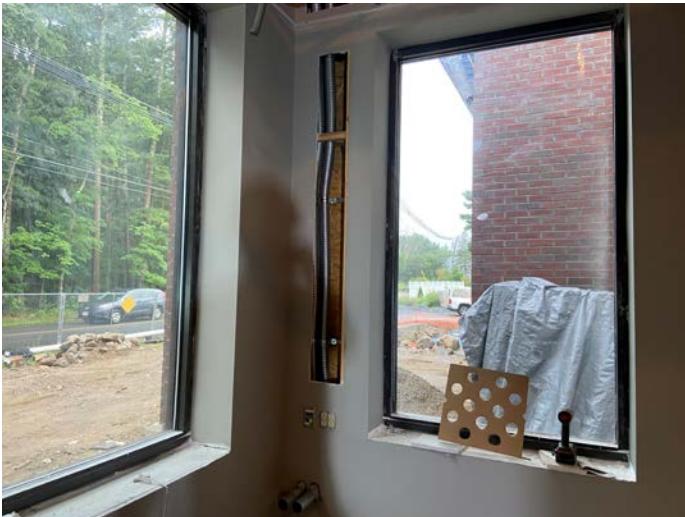
Fire alarm conduits installed

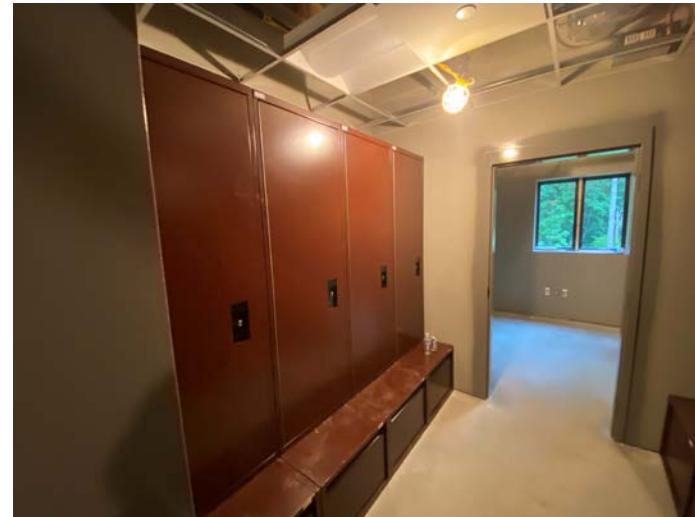
Duty lockers installed. Bench and top to be installed

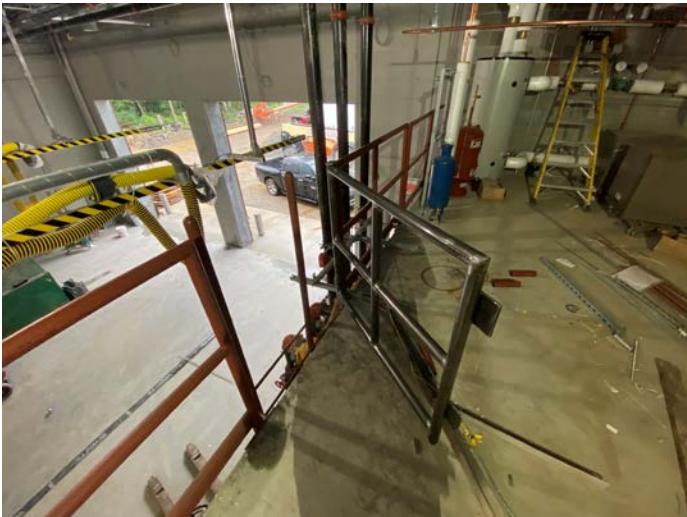
Mechanical mezzanine swing gate fabricated

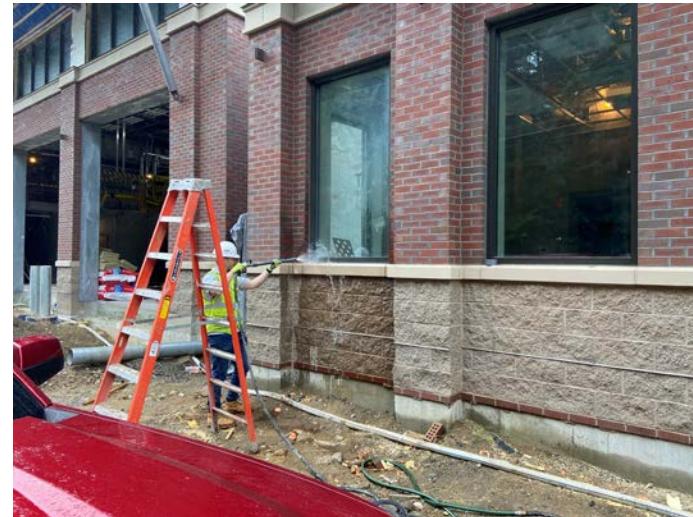
Water testing at watch room

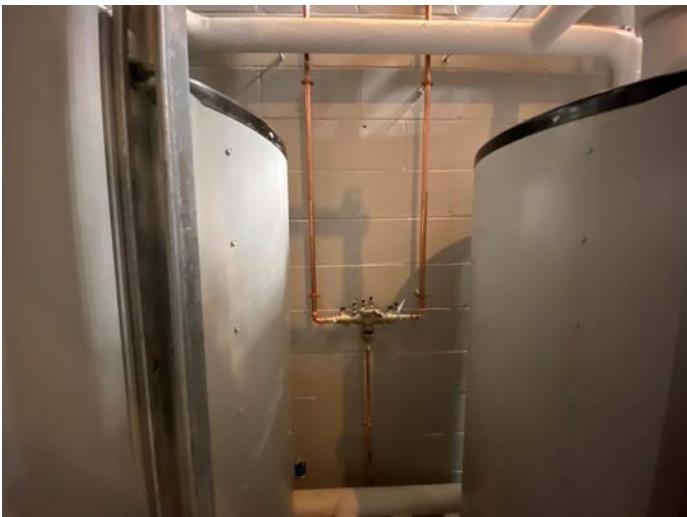
Backflow preventer behind water tanks moved down and bypass removed. Water dept coordinated

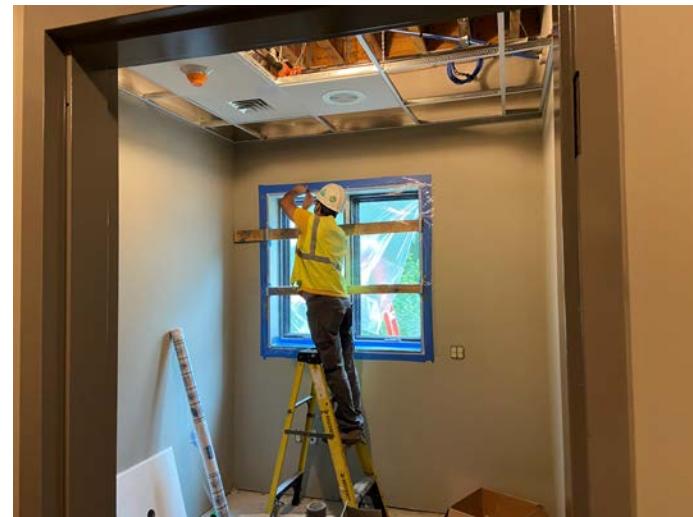
Set up for bunk room window testing

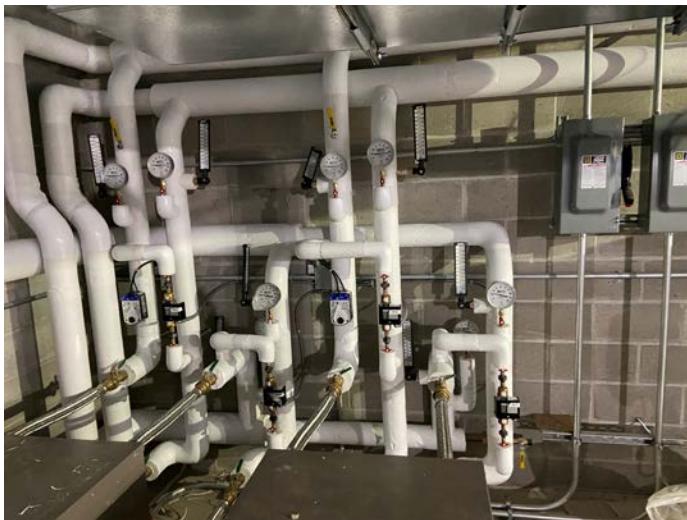
Mechanical mezzanine pipe insulation

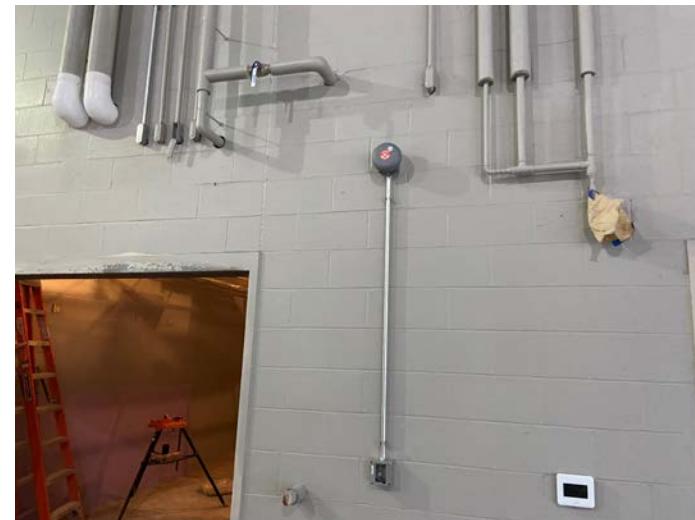
Fire alarm bell installed

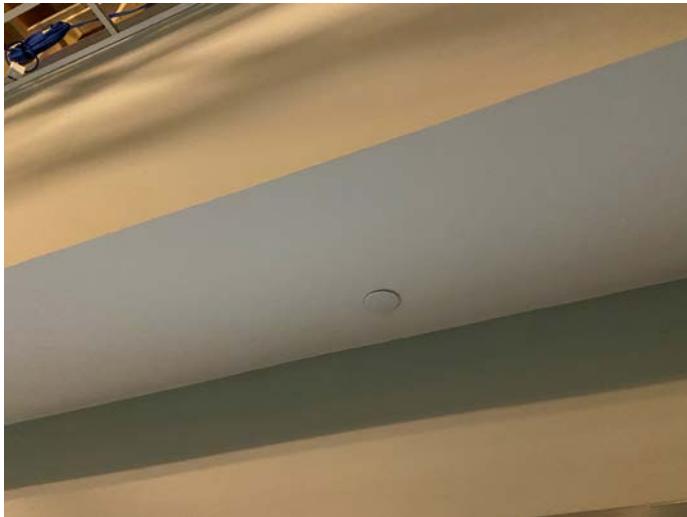
Typical fire sprinkler finishing

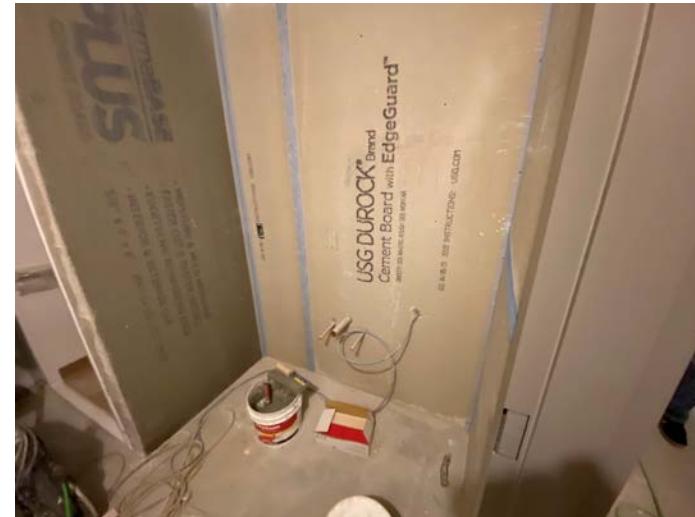
Taping bathroom wall joints for thin set mortar
