# Stretch code as quality assurance— for consumers *and* builders

Paul Eldrenkamp  
paul@byggmeister.com

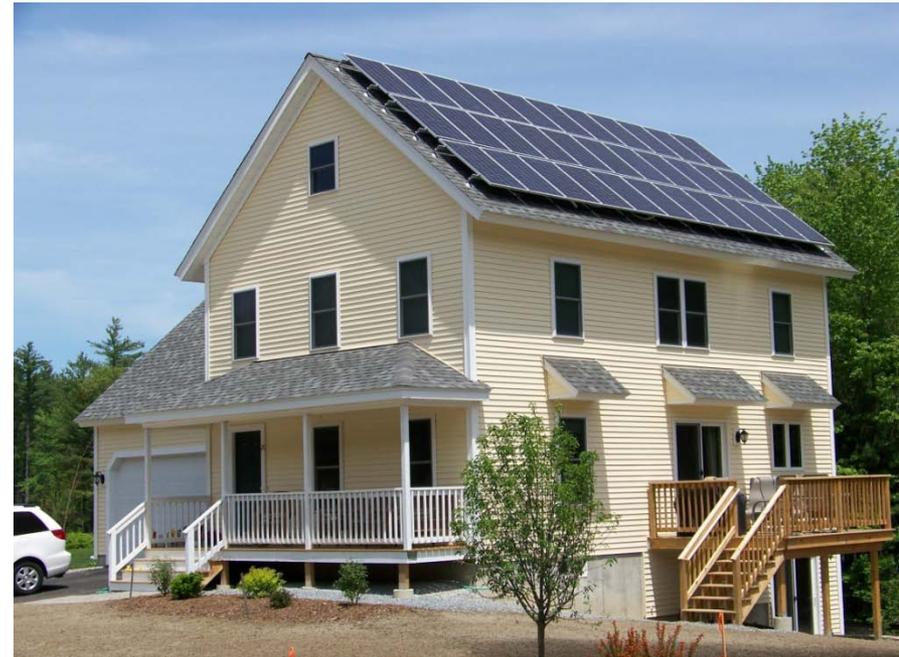
# New construction: Townsend, MA

Builder: Transformations, Inc. / Carter Scott  
Cost of construction: Less than \$150/ft  
HERS index: -4 (net energy producer)

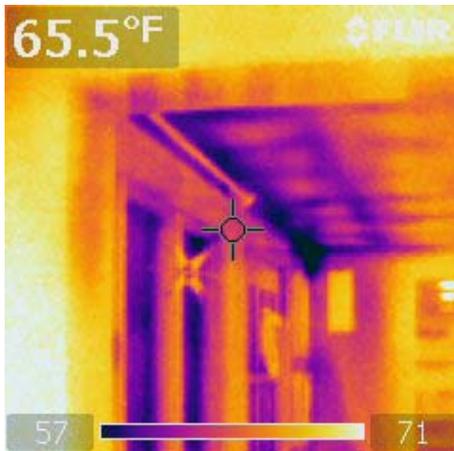
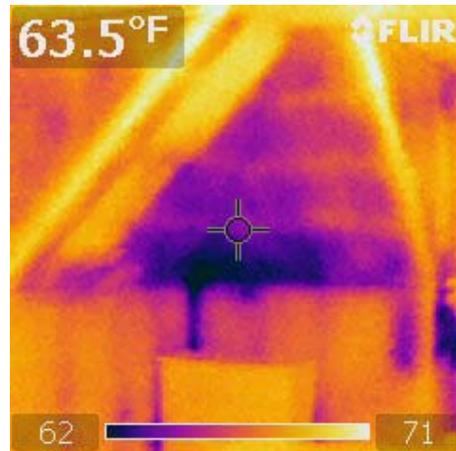
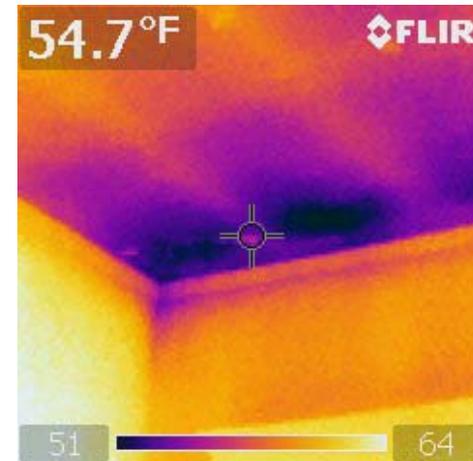
# Infrared images showing flaws in insulation—new construction

Darker areas are colder; lighter areas are warmer

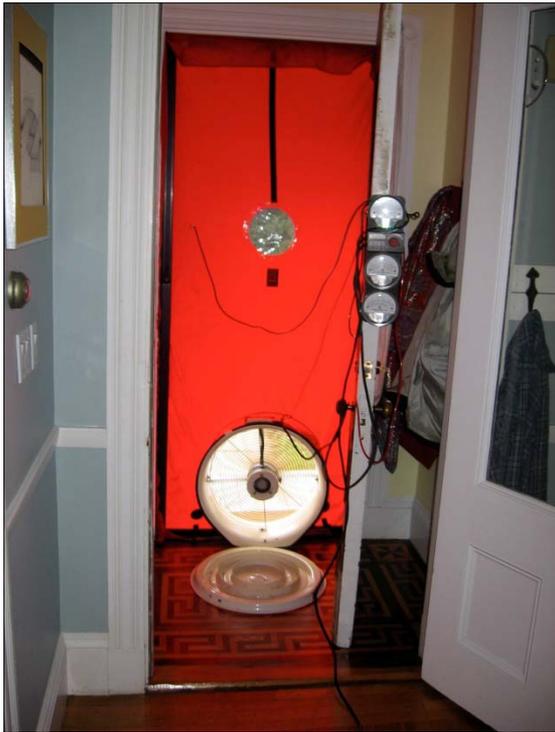
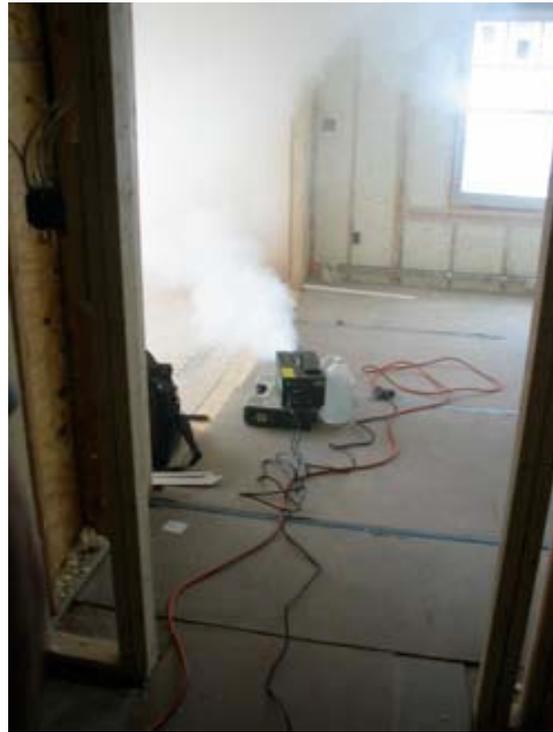
# Blower door testing

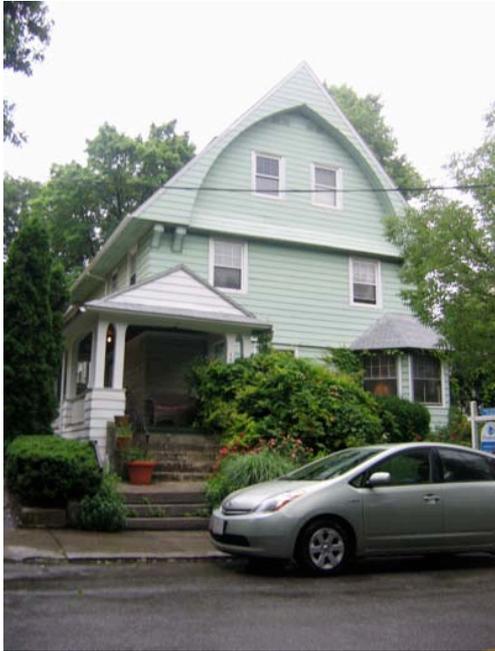
# Case study: Brookline

Baseline HERS		128
Well-installed cellulose in above-grade walls	-16	112
Air leakage reduction from 8150 CFM50 to 2100 CFM50	-22	90

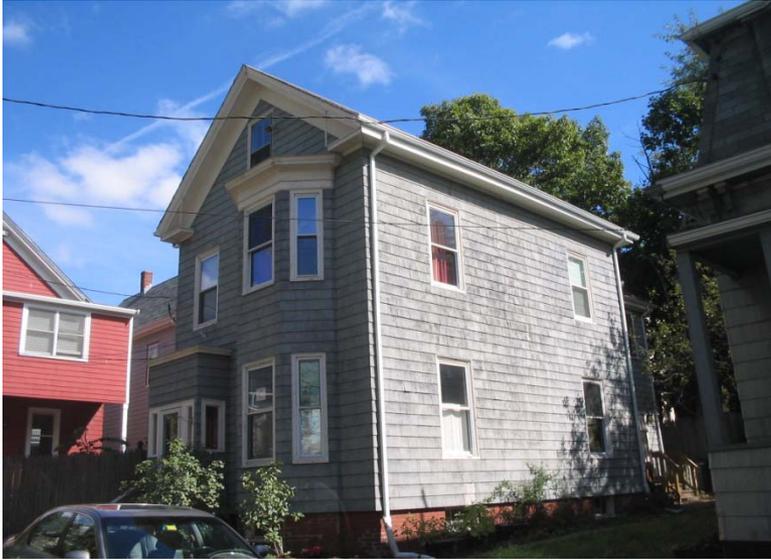
# Case study: Cambridge

- Pre-project HERS index: 171
- Post project: 87
- Improvement measures:
  - High efficiency boiler
  - Basement wall insulation
  - Attic insulation
  - Air sealing (9500cfm to 4500cfm)

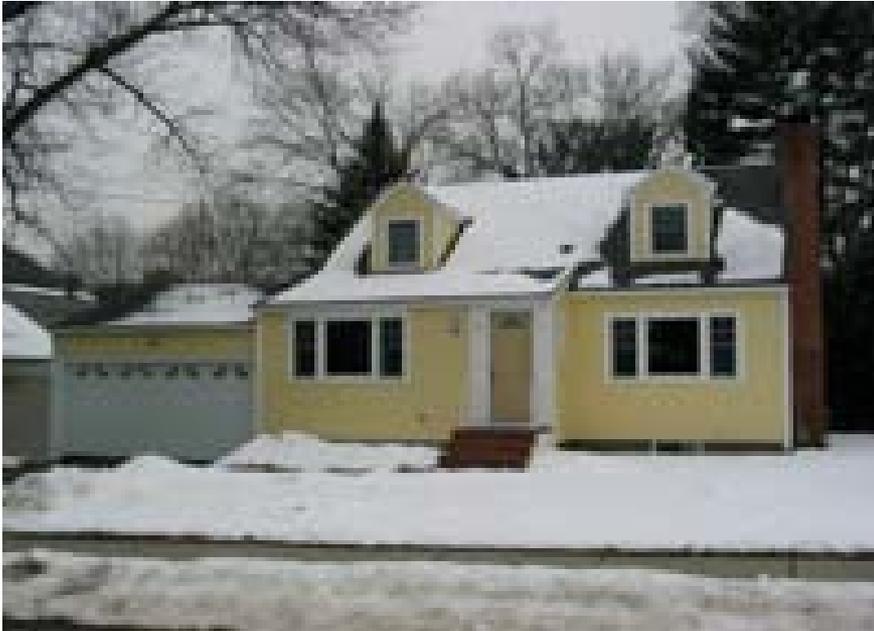
# Case study: Newton

- Pre-project HERS index: 140
- Post-project index: 75
- New windows
- Spray foam in walls and roof
- Blower-door testing during renovation

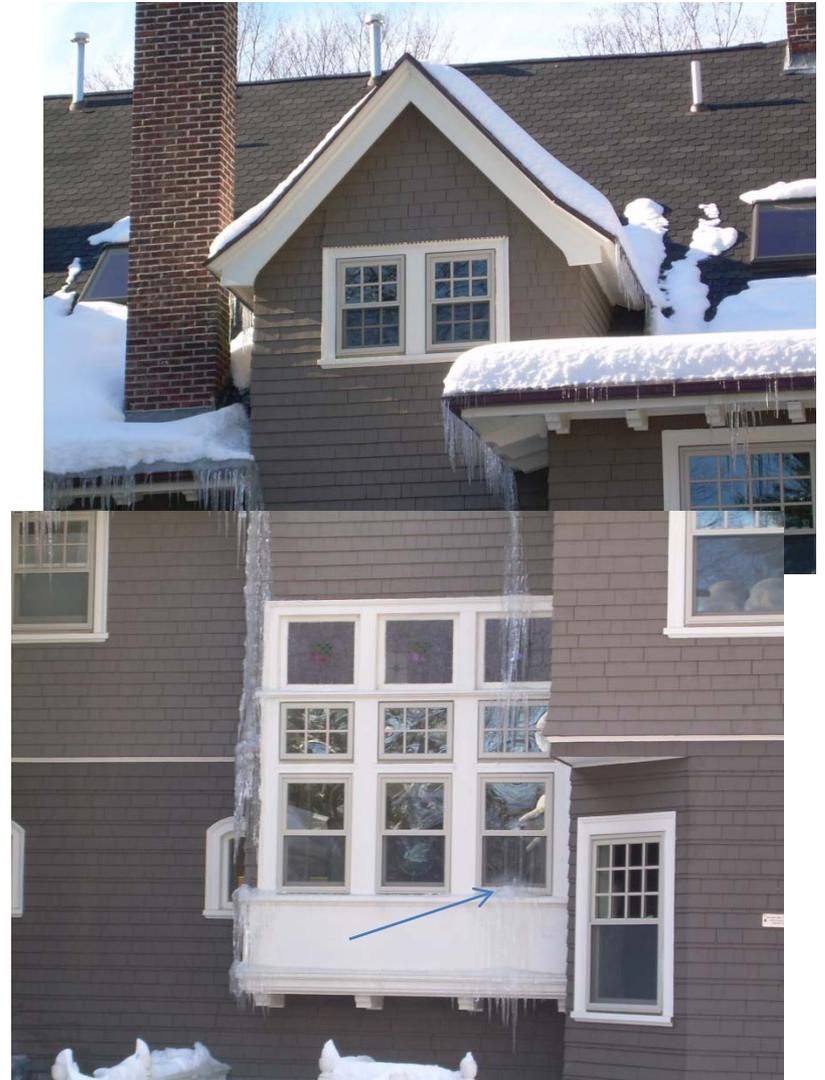
Insulation too short!

Like the current code, the stretch code requires air sealing and a “complete” thermal envelope...no room for gaps

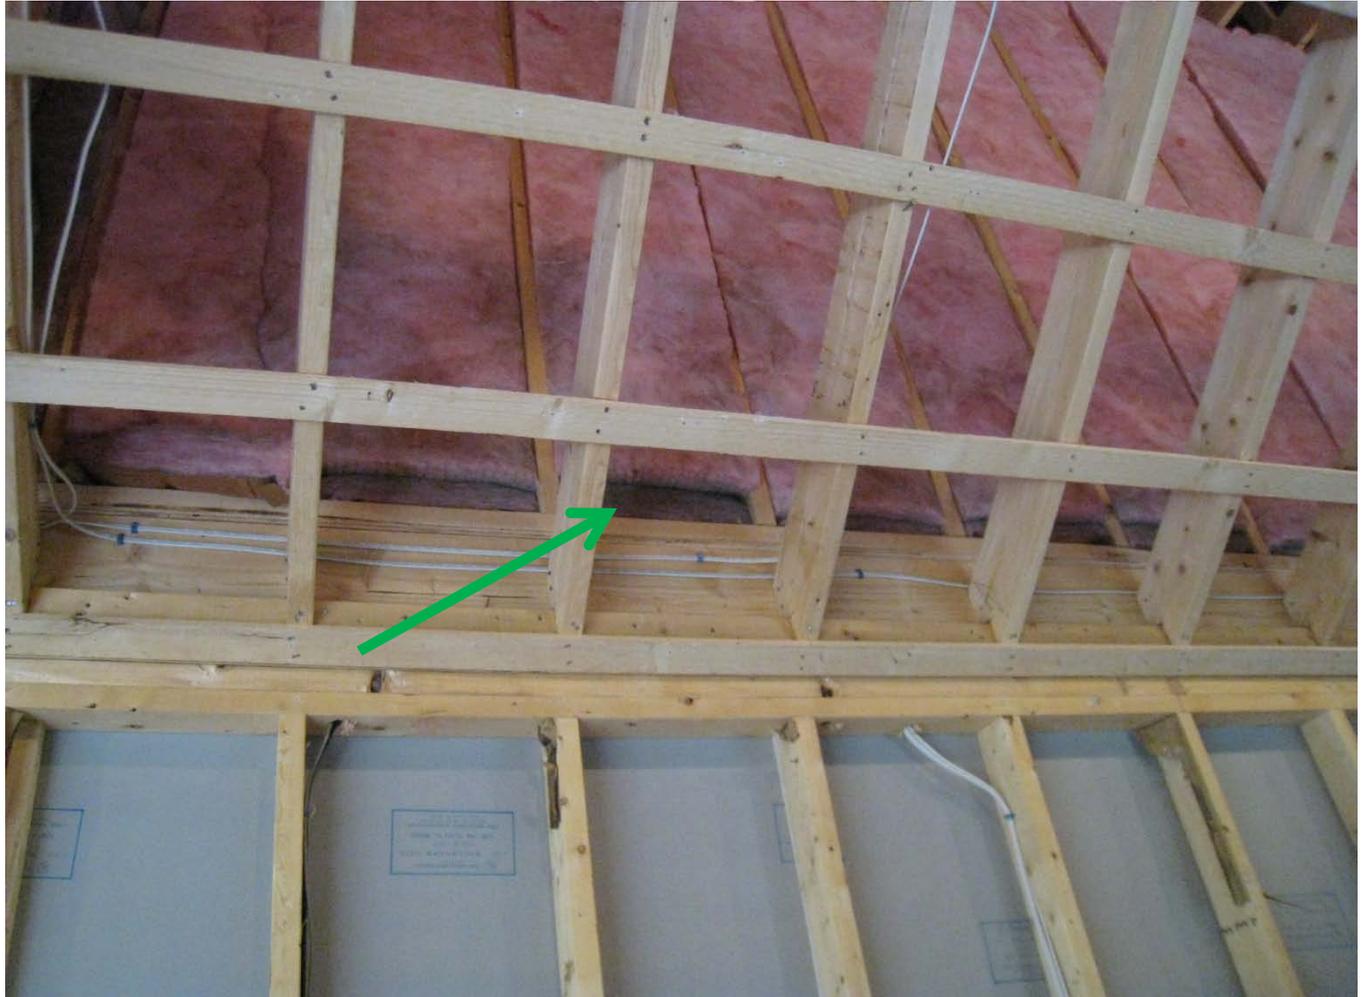
Insulation poorly fitted, gaps – allows lots of air leakage

Again, the stretch code is requiring the same amount of insulation and air sealing as in the current code, but with better installation practices.

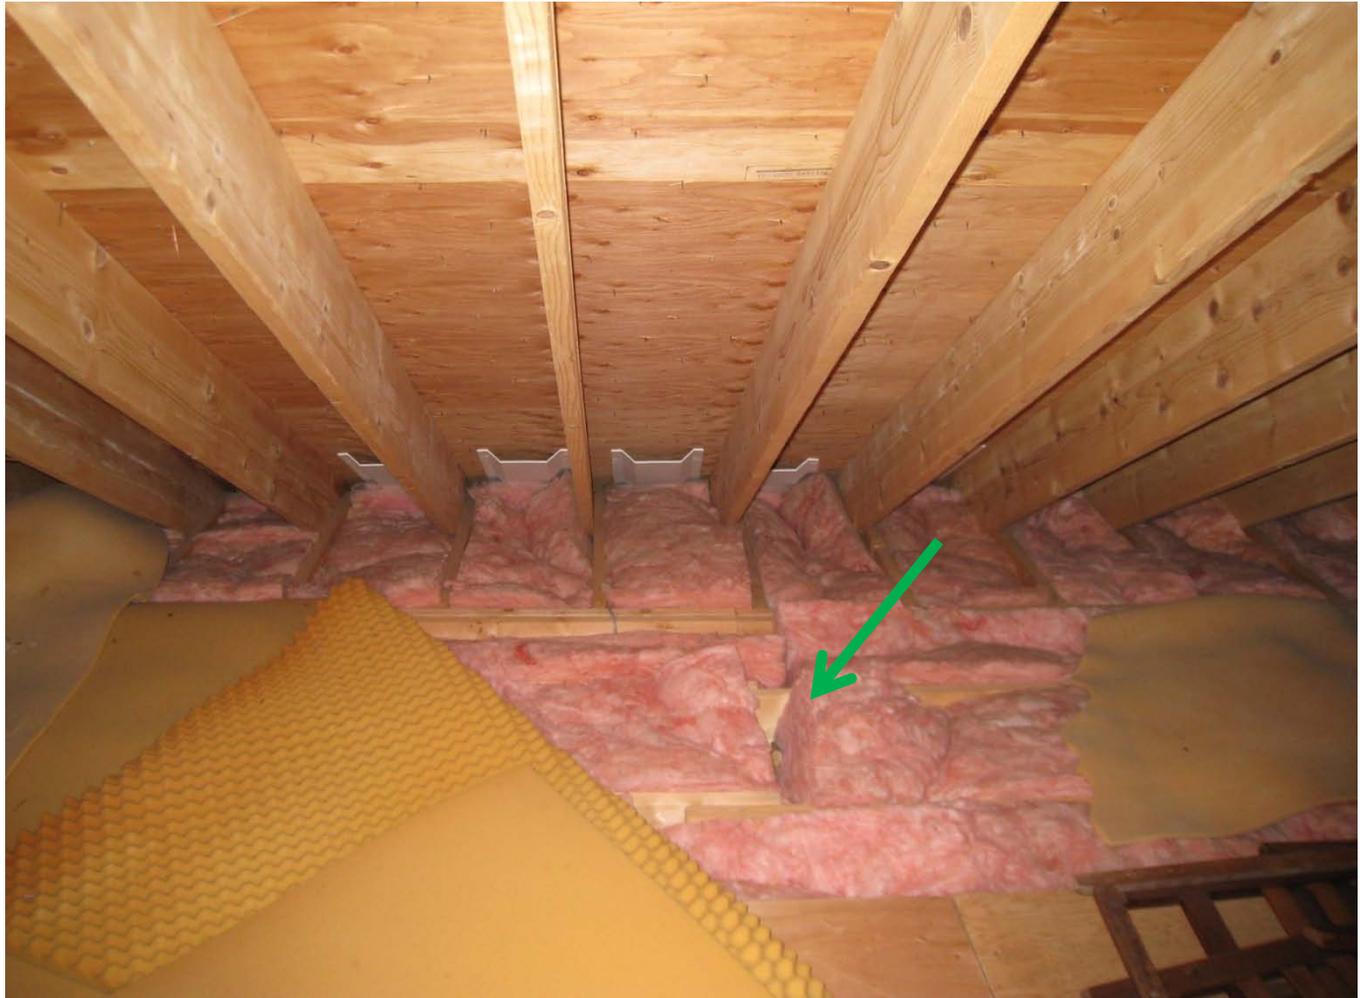
5-1/2" of dense pack cellulose, 3.5#/cf allowed us to achieve a HERS 70 on this renovated carriage house. We used some spray foam to "coat" a steel beam and reduce its thermal conduction. A blower door gives us better quality control and ensures compliance.
