**Town of Acton, Massachusetts**

**Final Report  
Morrison Farm Feasibility & Preliminary Design Study**

## Feasibility Study Existing Conditions: Architectural

Morrison Farm  
Acton, MA  
HVAC Existing Conditions Systems Report  
J#839 012 00.00  
L#28754/Page 1/June 19, 2009

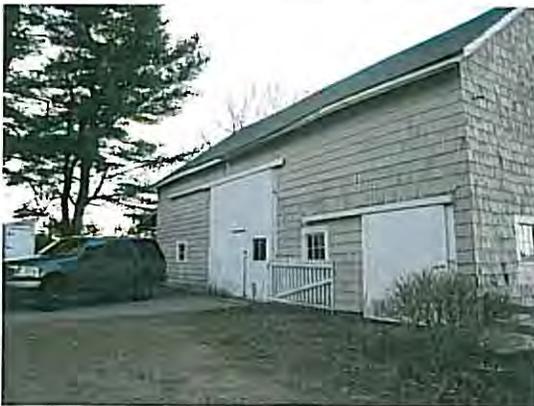
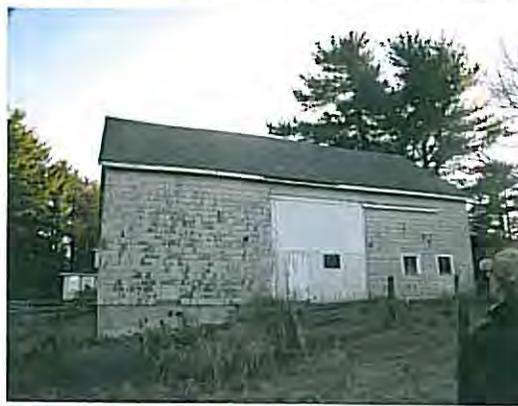
The approximately 30'x50', timber-framed barn, shown on Drawing "A", is about 14.5' tall to its eaves. It has second level lofts to either side of the roughly 12' wide center aisle through the barn, running south to north. There are no lofts at the eave level to hold the walls plumb so they have bowed outwards a few inches and are currently stabilized by front-to-back (south-to-north) steel rods or cables at about the 1/4 points along the 50' length of the barn. Its floor is a concrete slab-on-grade. The foundation, shown in the following photos, is of concrete having large stones cast in and periodically visible on the surface.

← North side  
(Rear)

Far left photo  
is the South  
side. (Front)

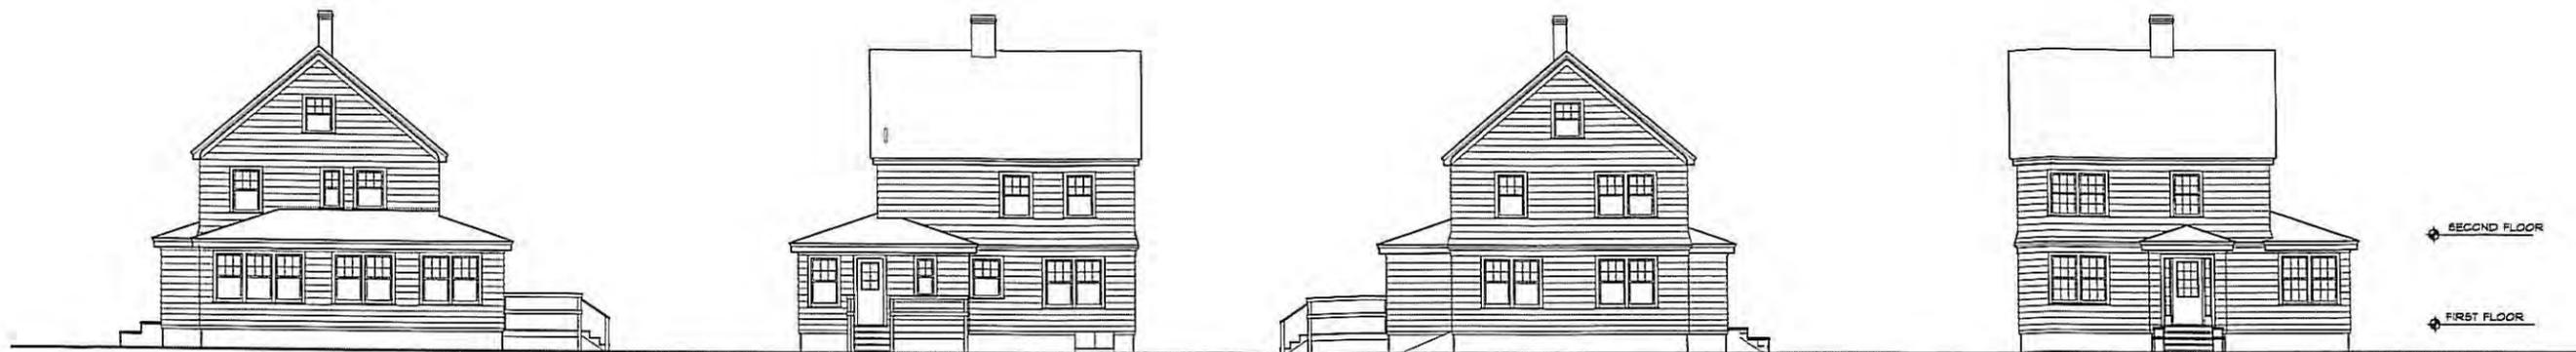
HOUSE ELEVATIONS

The locations of the house and barn are shown in the "Building Layout" plan on the attached Drawing "A". The elevations and floor plans of the house are shown on drawing "B". The main part of the house, approximately 24'x 26', is two stories high plus a basement and walk-up attic. The front entrance, on the south wall, is a small vestibule that leads to another entry door into the Living Room. On the right side (east side) of the house is an enclosed porch running the length of that side and wrapping partially around the rear wall to the rear exit. The northeast corner of the porch has some hidden degradation and a poor foundation condition so will probably need replacement. There is no exterior or basement access into the crawl space under this section of the porch floor.

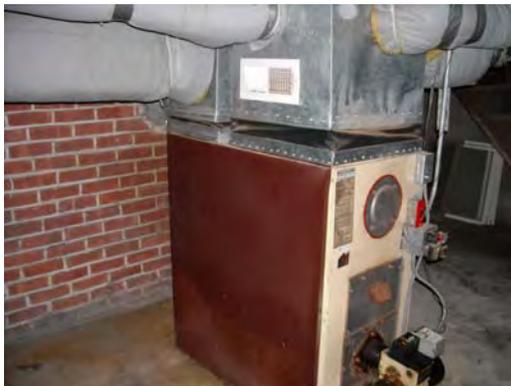
Presently, the Heating and ventilation system serving the Farm House is an oil fired force hot air furnace system. The system appears to be in fair to poor condition. In general, the heating and ventilation system has served it's useful life. As part of a building renovation project, we recommend installing a complete new heating and ventilation system. Central air conditioning should also be considered as part of a system upgrade project.

The Farm House is heated by an oil fired forced hot air furnace system. Warm air is delivered throughout the house by a combination of galvanized metal and flexible ductwork that is connected from the furnace and routed to floor supply air diffusers. Return air is typically ducted back to the furnace unit by a galvanized sheet metal duct system that is connected to wall return registers. The furnace is located in the basement and was manufactured by Hallmark Co. (Model #LBD85, w/ 0.57 GPH Carlin Burner). The furnace discharge temperature is controlled by a wall mounted line voltage space thermostat located in the first floor living room. The building is naturally ventilated by operable windows.

Illustration 1: Oil Fired Air Furnace

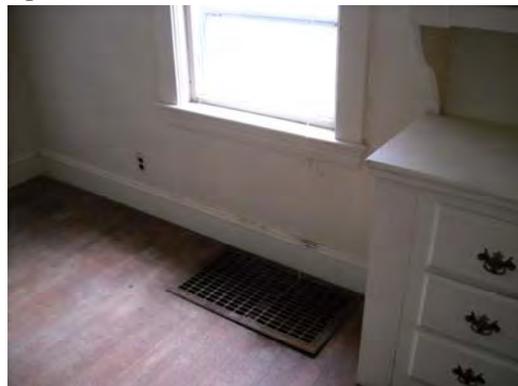
Illustration 2: Typical Floor Supply Diffuser

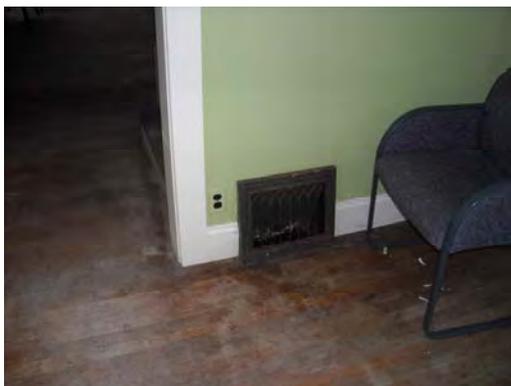
Illustration 3: Typical Wall Return Air Register

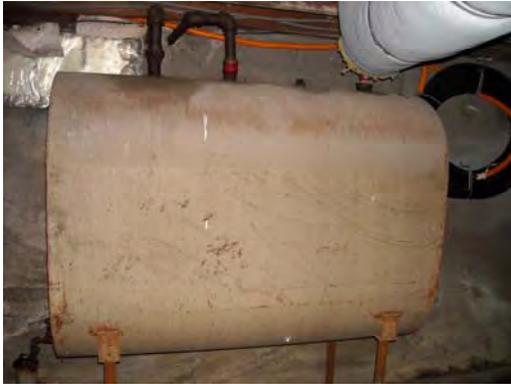
Fuel oil for the furnace is stored within a 277 gallon fuel oil tank located in the basement. Fuel oil vent and fill lines terminate outside the building as required by code. The fuel oil tank and piping appear to be in fair condition.

Illustration 4: Fuel Oil Tank

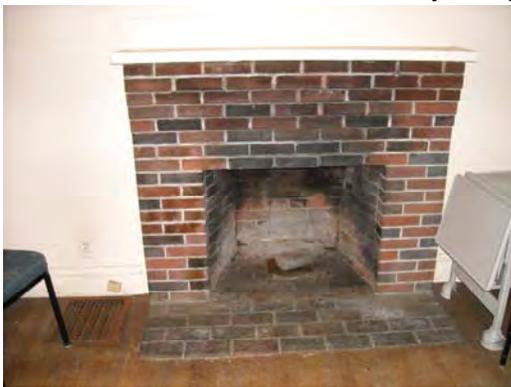
There is a fire place located in the central living room on the first floor. The brick work appears to be in fair condition. However, the chimney lining was not observed during this field visit.

Illustration 5: Living Room Fire Place

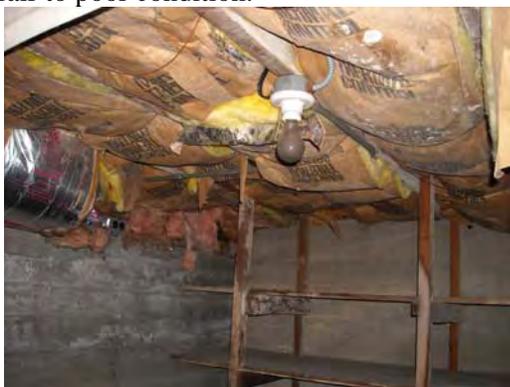
Lighting fixtures generally are residential wall and ceiling type with incandescent light bulbs. These are in fair to poor condition.

*Existing lighting in basement with three methods of wiring.*

Complete new interior wiring, lighting and receptacle systems are recommended.

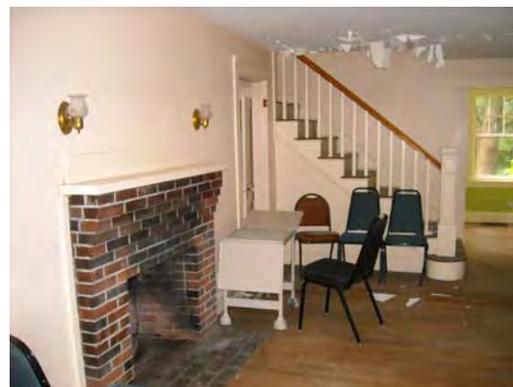
*Existing lighting on the wall.*

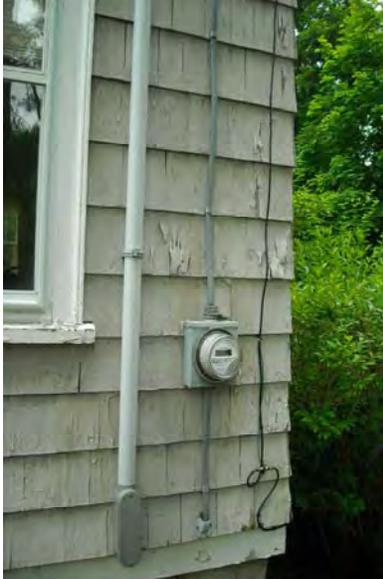
*Incoming Electrical Service to the Meter*

Installation of a new electrical wiring from the weatherhead is recommended. The panel is 100Amp with 20 poles and should be replaced.

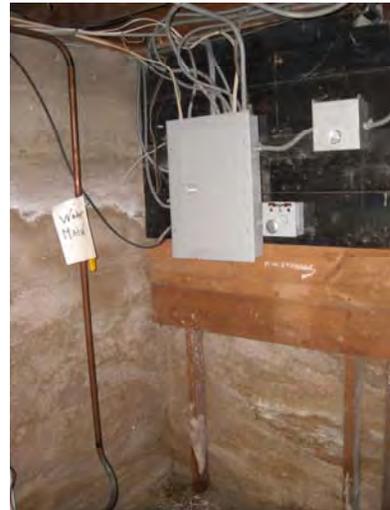
*Electrical Service Panel with mixed wiring*

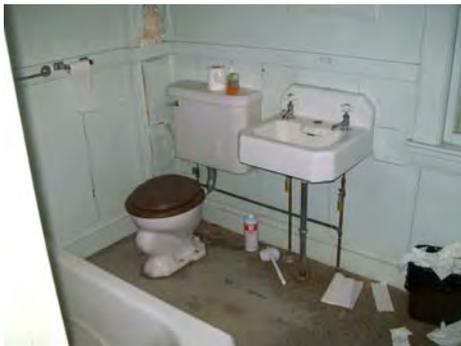
Plumbing fixtures generally are in poor condition and are not in use. Fixtures include a kitchen sink located on the first floor and a bathroom group on the second floor.

Lavatory are wall hung vitreous china, with hot and cold water handle faucets, non-water conserving.

*Floor mounted water closet and wall hung lav*

Installation of all new water conserving fixtures is recommended.

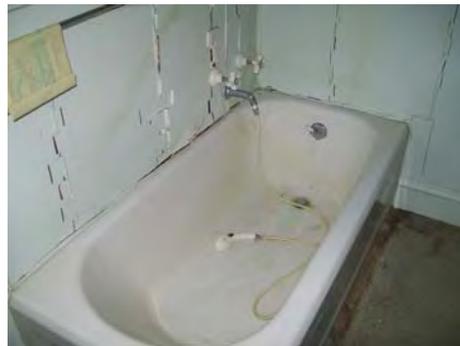
Bath tub is vitreous china with hot and cold water handle faucet with hand spray shower.

*Tub/shower*

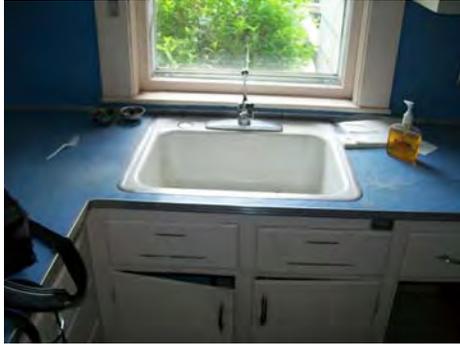
Kitchen sink is counter mounted with single handle faucet; no hose spray.

*Kitchen Sink*

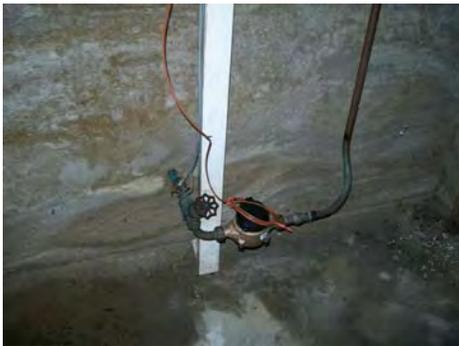
Piping is copper with sweat joints. The piping is not insulated. There is a 1/2" cold water feed to a hose bibb located in the Barn from the basement.

*Domestic water service*

Complete new water piping systems are recommended. The copper piping is in poor condition and has served its useful life.

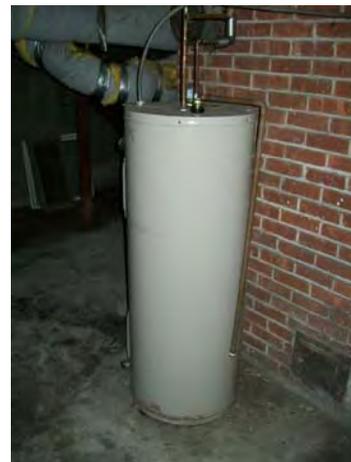
Domestic hot water is generated through an electric tank type water heater; 50 gallon storage, 240 volt, single phase, 4.5 kW. There is no thermostatic mixing valve on the system to prevent scalding.

*Domestic water heater*

Installation of a new hot water heater with thermostatic mixing valve is recommended.

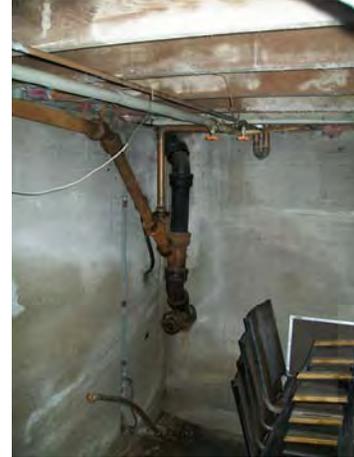
There is a 4" cast iron sanitary service to the exterior septic system. Where visible, the cast iron pipe appears to be in fair condition. Smaller pipe sizes are copper.

*Sanitary service*

Generally the cast iron could be reused even in a major renovation provided it is sized appropriately.
