**TOWN OF ACTON
HISTORIC DISTRICT COMMISSION**
472 Main Street, Acton, MA 01720

CERTIFICATE OF APPROPRIATENESS

Location of Work 285 Arlington Street, Acton, MA District: Center West South

Description of Proposed work: Partial demolition and reconstruction of barn and attached garage located behind residence.

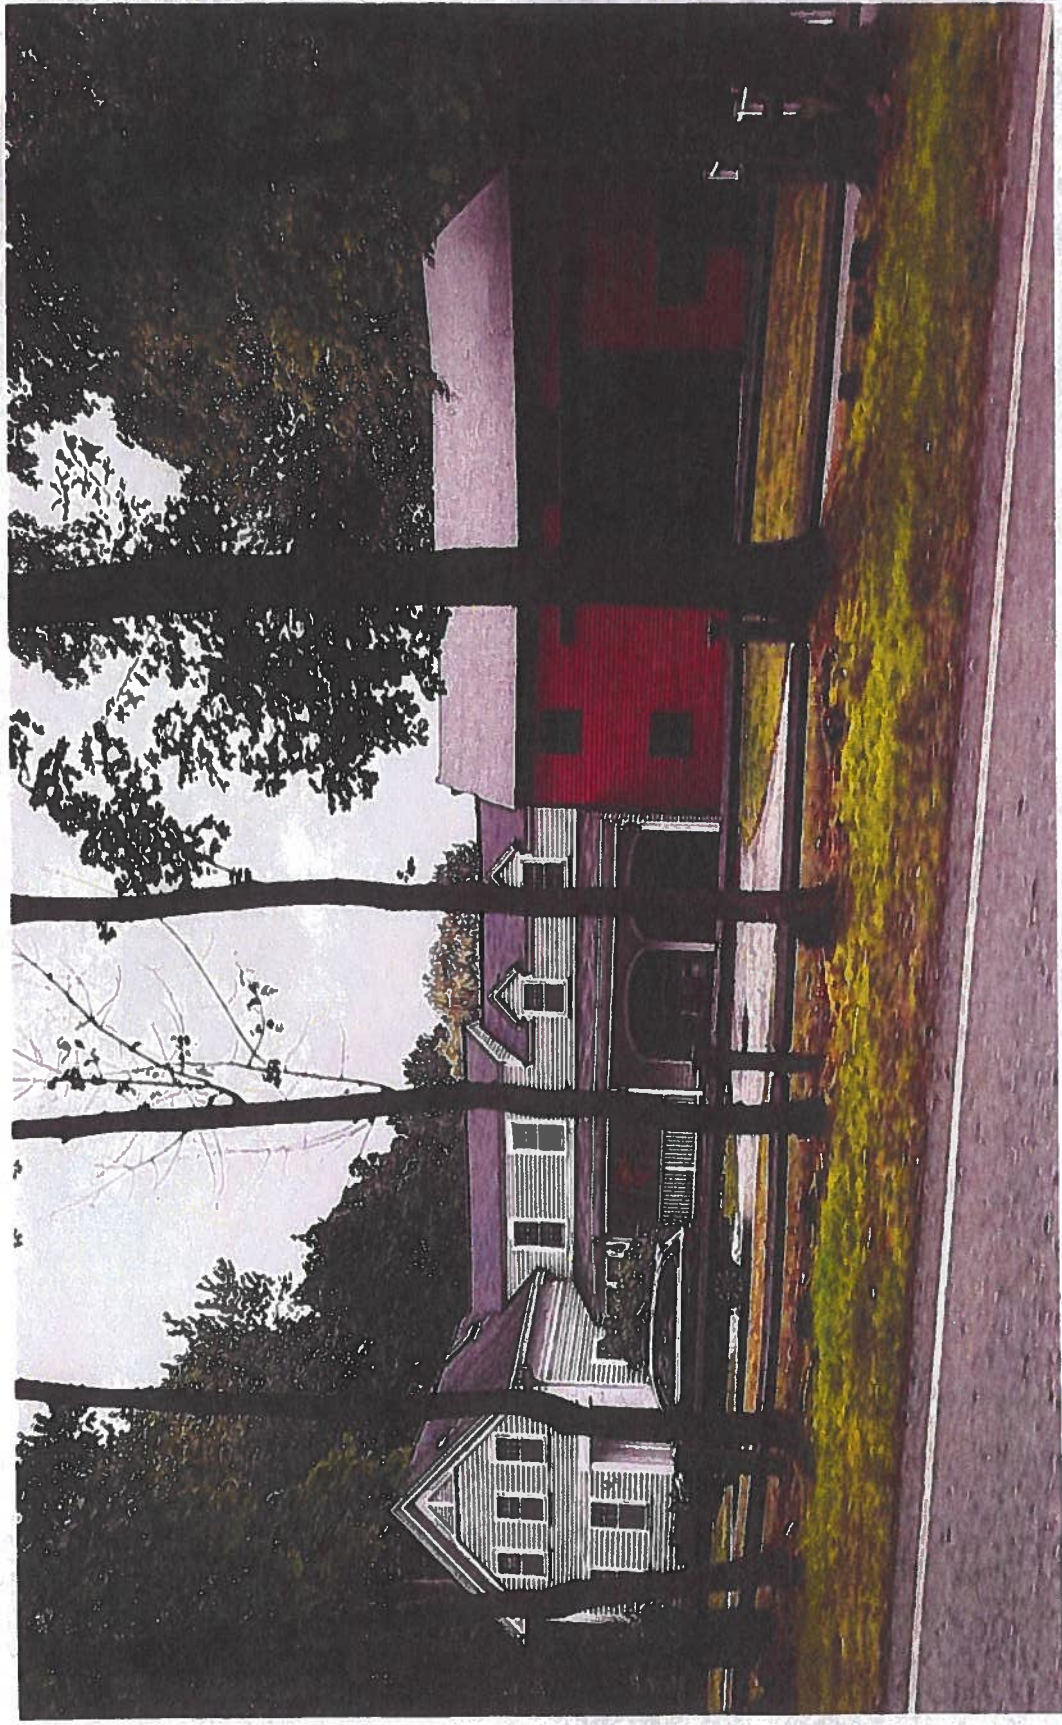
“Carriage” bay for car storage
